MAKING YOUR MITIGATION SYSTEM MORE EFFECTIVE

A TECHNICAL GUIDANCE MANUAL

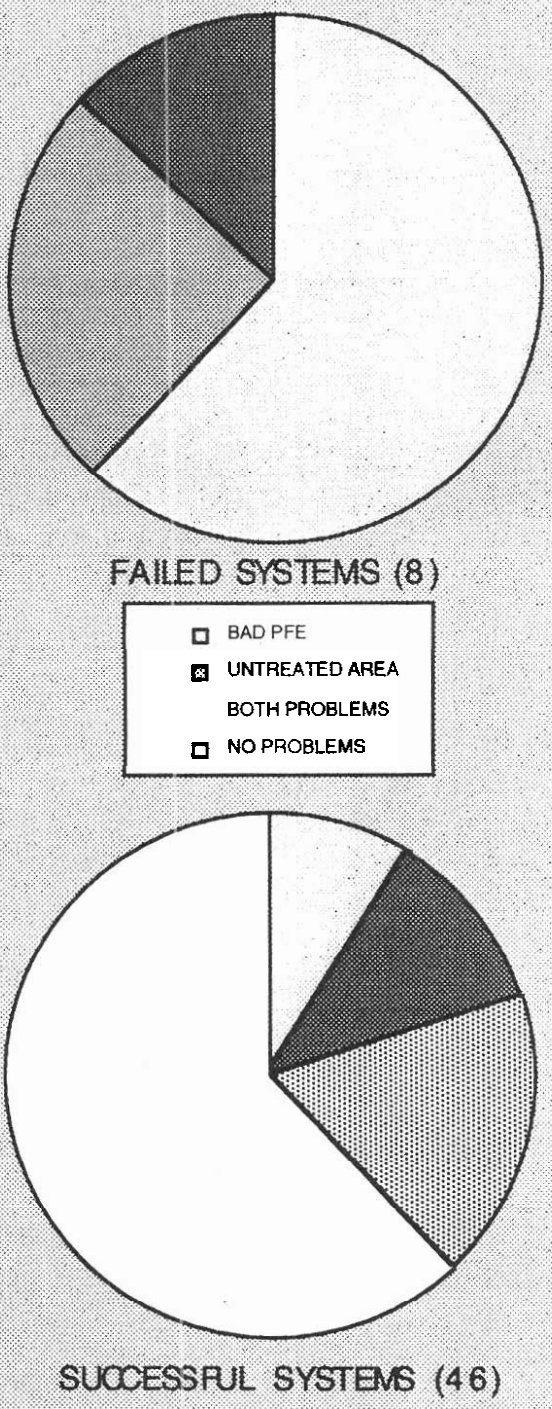
Figure 2. Sub-slab depressurization system deficiencies.

Figure 2 presents a summary of the deficiencies found in failed and successful sub-slab depressurization (SSD) systems. A total of 54 SSD systems were investigated. Of the eight systems that failed, every one either did not develop an adequate pressure field, failed to treat a ground

contact area, or both. The most prevalent deficiency was the lack of an adequate pressure field. Five (62%) of the houses where the sub-slab depressurization system was a failure had an inadequate pressure field. Two (25%) of the homes with a failed sub-slab system had untreated areas. One (13%) of the homes had both deficiencies.

Forty-six of the SSD systems were successful. Seventeen (38%) of the successful systems did not develop an adequate pressure field, had untreated ground contact areas, or both. Four (9%) of the successful systems did not develop an adequate pressure field. Eight (18%) of the systems failed to treat a ground contact area. Five (11%) of the systems had both deficiencies. Twenty-nine (63%) of the systems had no deficiency.

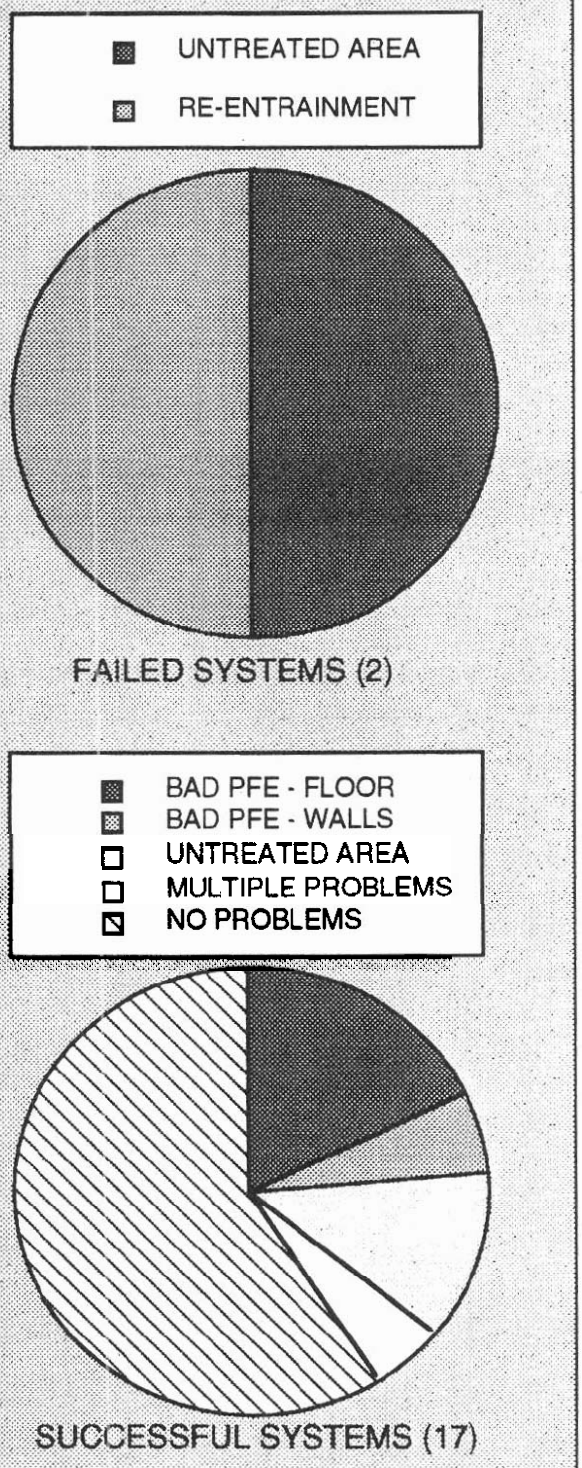
Figure 3. Failed and successful SSD/BWD depressurization systems.

A total of 19 homes had combination SSD/BWD systems installed. Of those 19 systems, two failed to maintain radon concentrations below the 4 pCi/L level. The two failed systems both developed an adequate pressure field beneath the slab and within the block walls. One failed system did not treat a crawlspace, and the other was installed with the exhaust close to an outside entrance to the basement. Additional measurements indicated that exhaust entering the basement through the exterior door was the cause of the elevated radon levels.

Analysis of data collected revealed that ten (59%) of the successful SSD/BWD systems were developing adequate sub-slab and wall pressures, and were treating all ground contact areas. Three (18%) of the successful systems failed to develop an adequate sub-slab pressure field. One (6%) failed to develop an adequate wall pressure. Two (12%) failed to treat a ground contact area. A single SSD/BWD system had two problems.

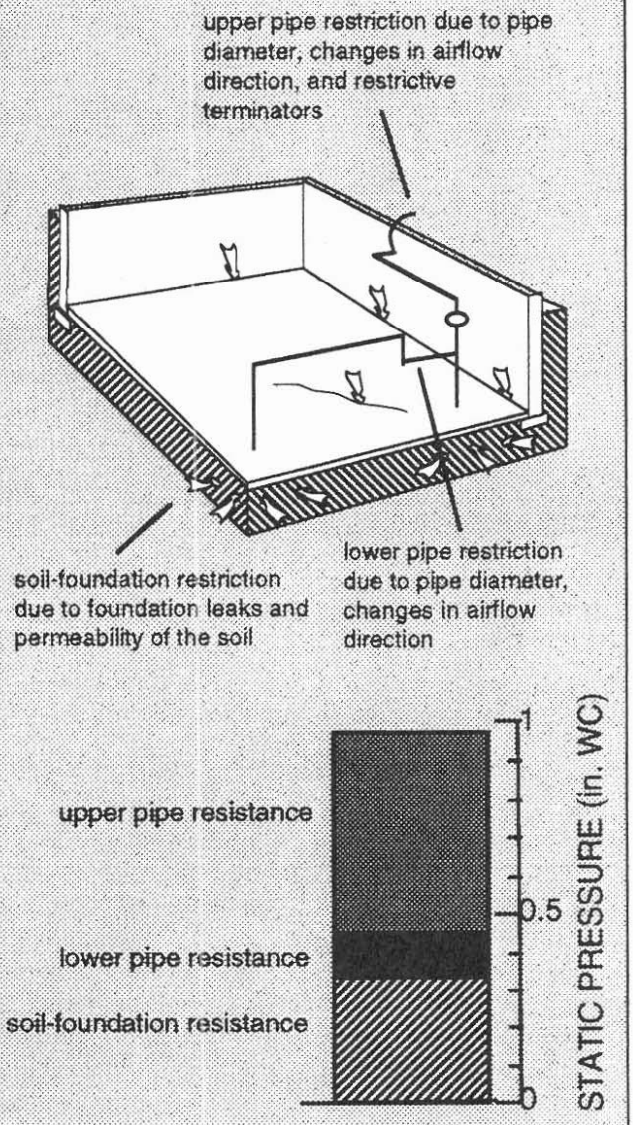
Figure 5. Example house ASD system layout and static pressure due to component restrictions.

To further illustrate the resistance elements, we will describe one of the ASD systems investigated during the project. The system layout is illustrated on Figure 5. The system was a two-point ASD system with the fan located in the basement. Visualize the path that the exhausted air takes on its journey. The air moves through the soil, into and through the pipe system below the fan. It travels through the fan into the pipe system above the fan, and finally, is exhausted outdoors. As it

moves through the system, its movement is hampered by the five resistance elements that we have just discussed. The soil-foundation resistance in our example system is -0.332 inches WC. (We measure the resistance to airflow, also called static pressure loss, using a differential pressure indicator, therefore the units of measure are usually inches of water column or Pascals.) The resistance in the pipe system below the fan is -0.118 in. WC. The lower pipe system consists of about 40 feet of pipe, and has four changes of airflow direction. The upper pipe resistance is 0.530 in. WC. The pipe system above the fan includes approximately 30 feet of pipe, four changes in airflow direction, and a dryer vent cap as a terminator.

The resistance in the upper pipe system is quite high. In fact it is greater than the other elements combined, and in particular, is greater than the soil/foundation resistance. In other words, the fan is doing more work getting the air out of the upper pipe system than it is getting it out of the soil. Figure 5 illustrates the resistance through each element. Notice that in the preceding paragraph, the signs for the soil and lower pipe elements are negative and the sign for the upper pipe is positive. The graph however, has all of the elements as positive. The total resistance in the system is the sum of the absolute values of all three elements.

Now that we have identified the resistance elements that can affect the strength and extent of the pressure field, let's look at an example of their affect on a particular ASD system. One of the ASD systems investigated was a single-point sub-slab depressurization system with no suction pit dug at the suction point, and a raincap on the end that was made from a 4 in. diameter PVC pipe cap. The pipe cap had thirty-two 1/4 in. holes drilled through it. This gave the system a total of about 6.3 square inches of area to exhaust through. Compare this to an open-ended 4 in. diameter pipe with about 12.6 square inches of area to exhaust through. The cap effectively decreased the 4 inch pipe to 2 inches. Pressure field measurements at various distances from the suction point were made with the system in its original condition, and with the raincap removed and a suction pit installed.

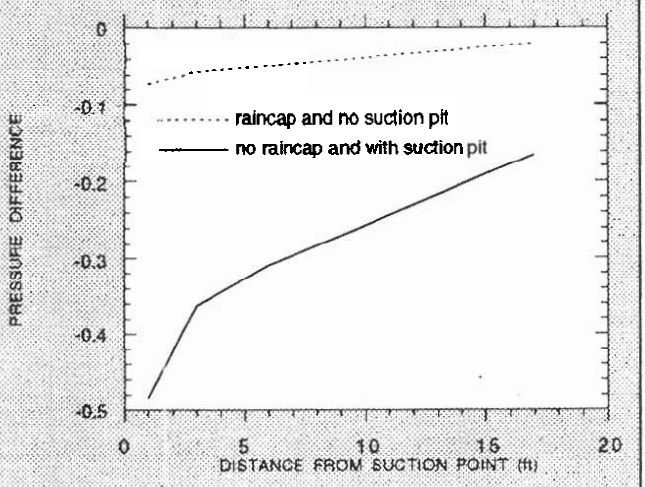
Figure 6. Sub-slab pressures versus distance from suction point before and after corrective actionns.

The pressure beneath the slab was -0.078 in. WC one foot from the suction point, -0.068 in. WC three feet from the suction point, -0.048 in. WC six feet from the suction point, and -0.020 in. WC 17 feet from the suction point. This is a pretty strong pressure field to begin with, but let's see how removing the raincap and digging a suction pit changed the pressure field. After the corrections, the new sub-slab pressure differences were -0.484 in. WC at the one foot test point, -0.363 in. WC at the three foot point, -0.310 in. WC at the six foot test point, and -0.166 in. WC at the 17 ft. test point. Figure 6 illustrates the pressure differences in the original system, and after the raincap was removed.

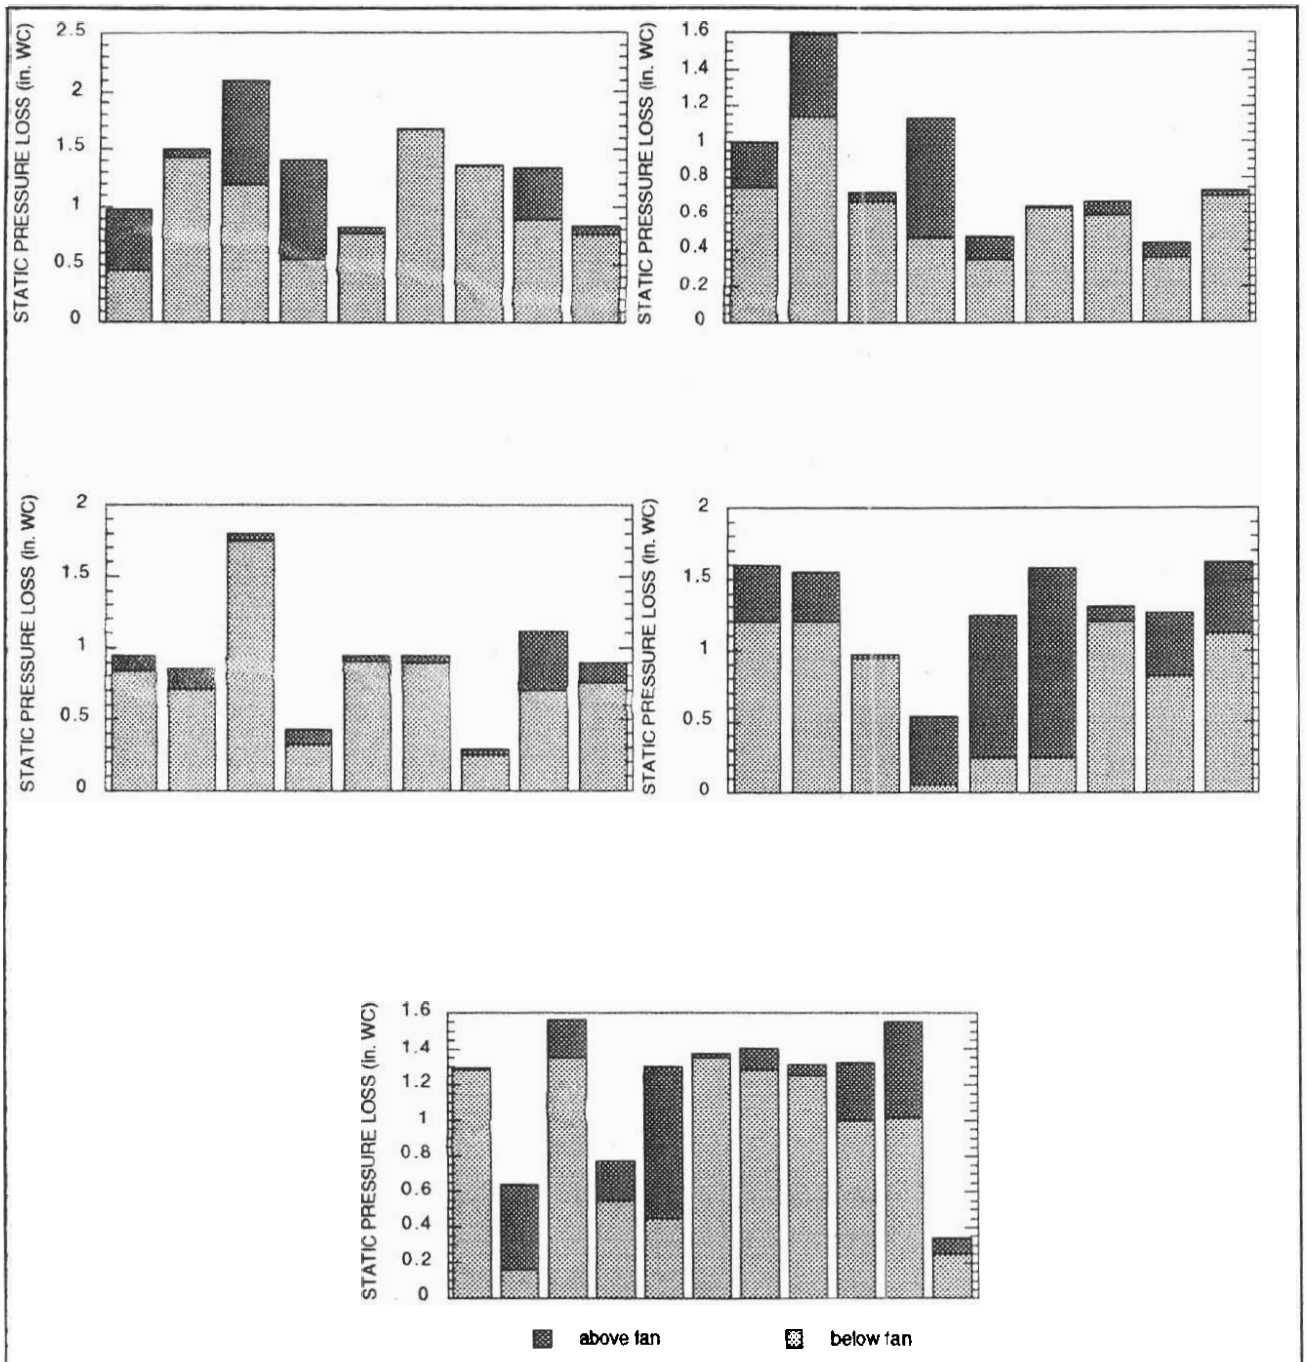
Figure 7. Results of system pressure measurements illustrating the resistance to airflow in ASD systems.

You may wonder how many ASD systems were developing a weakened pressure field because of high restrictions to airflow. Figure 7 shows the results of the measurements made in 47 of the ASD systems that were investigated. Each bar represents the pressure loss, and therefore illustrates the magnitude of the resistance to airflow of each element. The lower portion of the bars include the restriction due to the soil-foundation elements and to the pipe below the fan. The upper portion of the bars includes the restriction due to the pipe above the fan. Although it is not apparent from Figure 6, most of the ASD systems had a very small resistance due to the pipe below the fan. This was mainly due to the fact that most of the systems had the fans in the basement, and therefore, had short lower pipe runs. The most frequent cause of the restriction was a raincap placed on the end of the pipe. Another cause of restriction was the use of smaller diameter pipe, particularly a 2x3 inch rain downspout, on the outside of the house.

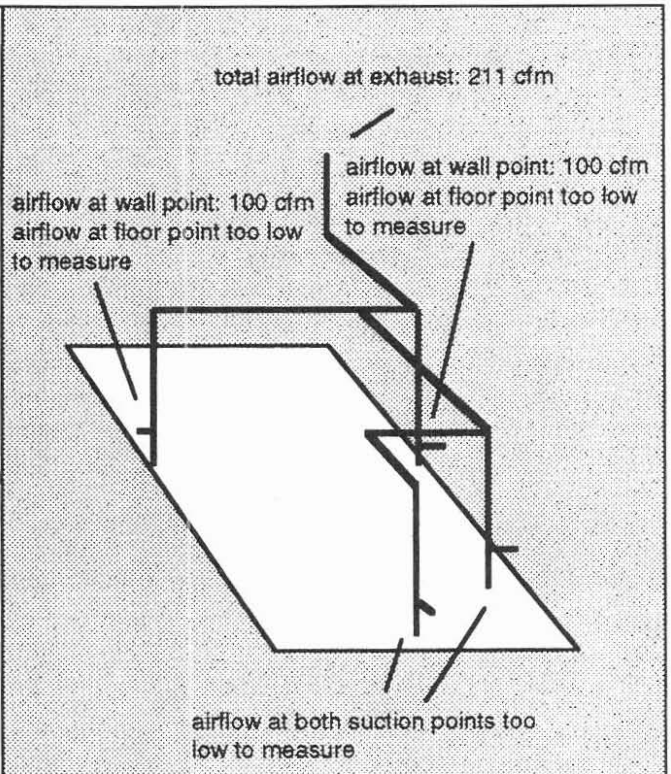
Figure 8. Layout of example combination ASD/BWD system.

A combination ASD/BWD system in a house investigated during the project serves as a good example of an unbalanced system. The system was installed with four slab and four wall suction points. There were no dampers installed in the system. Pressure field extension tests revealed that the system was developing a good pressure field within the block walls closest to the fan, but no pressure field within the other walls nor beneath the floor slab. Airflow measurements revealed that most of the air that the fan was moving was coming from the first two wall suction points. Airflows in the other two wall points, as well as the floor suction points, were too low to measure. Figure 8 illustrates the system.

It is very important to make airflow measurements in ASD systems that have more than one suction point. These systems may have to be tuned to ensure that all suction points are producing the desired pressure field. Airflow measurements made at each suction point will reveal if you need to adjust the dampers for a more evenly distributed pressure field. This is particularly important in combination sub-slab and block wall depressurization systems where the resistance to airflows in the two elements (the soil and the block walls) are usually quite different. It is normally much easier for the fan to draw air from within the block walls than it is to draw air from beneath the slab. If this is not planned for, then most, if not all, of the air that the fan can handle will come from the walls. This will result in no pressure field beneath the floor slab. It is not always possible to have equal pressure at each suction point, but it is possible to get some suction at each point.
